The Indiana Fluvial Erosion Hazard Mitigation Project

Operation Stay Afloat 2012
Embrace the Realities – Envision the Possibilities
Indiana Government Center
March 15, 2012

Robert Barr
Center for Earth and Environmental Science
Department of Earth Sciences
IUPUI

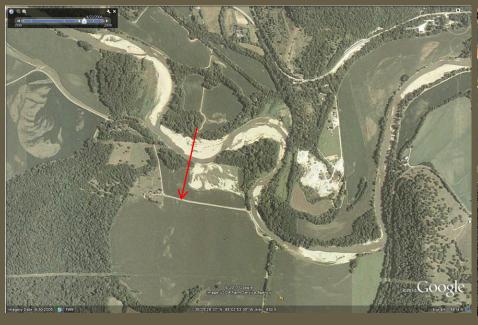
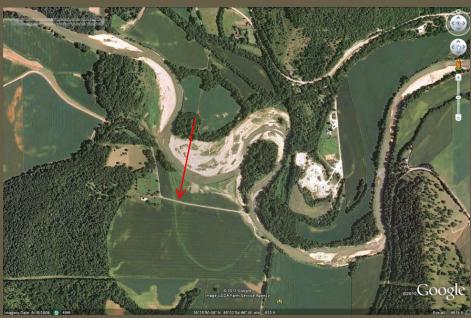
Whitewater River near Brookville, IN

Distance in 2006 = 1846 feet Distance in 2008 = 1812 feet 34 foot change/ 2 years

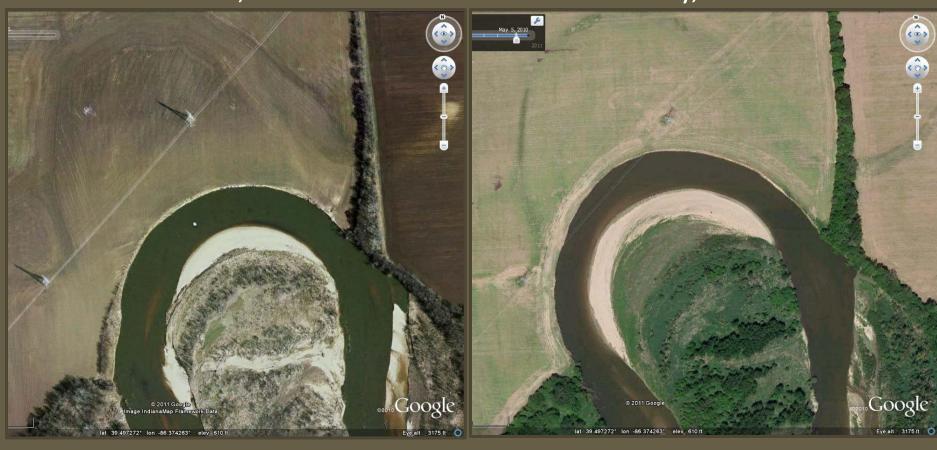
White River above Centerton, Ind.

Moved 290 ft in 5 years (58 ft/yr)

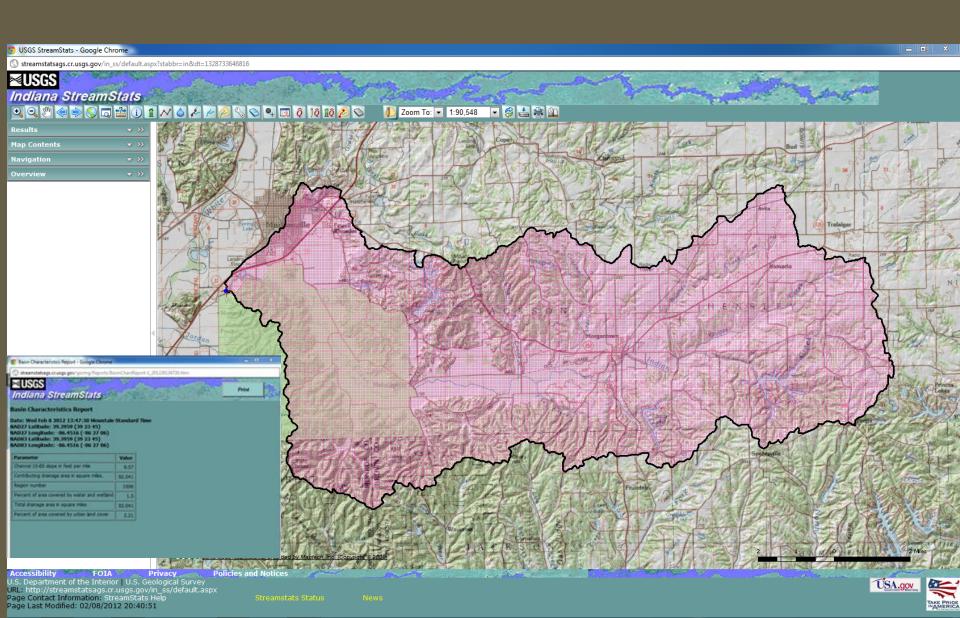
Indian Creek, Morgan County, IN

DA from USGS Streamstats = 92 mi² Wbkf predicted using Ohio Regional Curves = 90 ft Meander belt width = 540 ft (6 X 90 ft Wbkf)

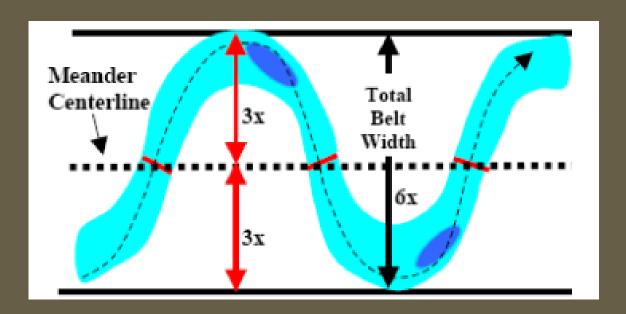
Outer meander belt lines of a low gradient, meandering channel

Meander belt width approx 6X Bkf channel width

Exceptions to the 6X channel width occur in steep, narrow valleys with resistant materials, or in more sensitive areas that require >6X

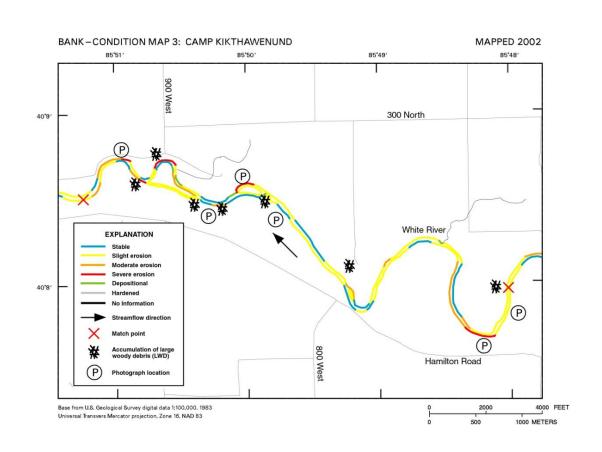
Bank-Stability Assessment Tool

Field Criteria

- Bank height
- Bank material
- Bank angle
- Vegetation condition
- Meander position

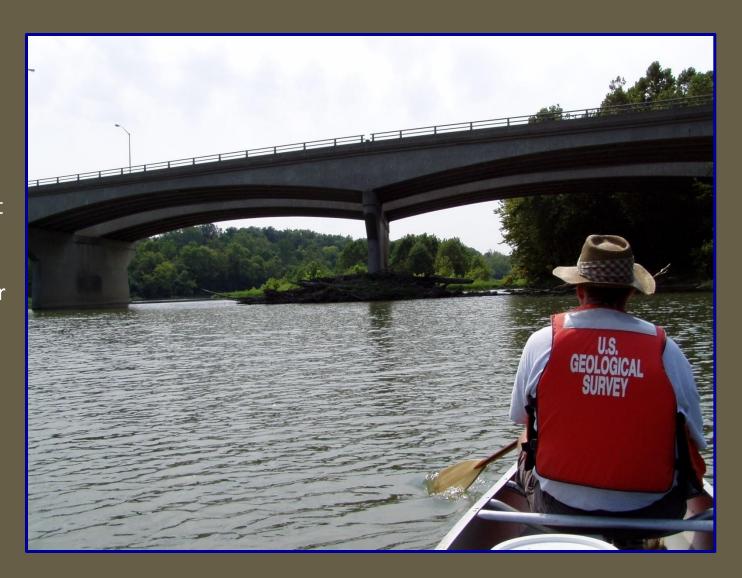
Bridge-Screening Tool

Based on USGS Level 1 bridge-scour methods (1990s)

- Bank material
- Bank stability
- •Bed material
- •Flow alignment
- Piers in water
- Woody debris
- Observed scour
